# Manhole Inspection Summary

Manhole # S19I1\_003MH

**Location** Address: **2500 southdene-marbourne alley**

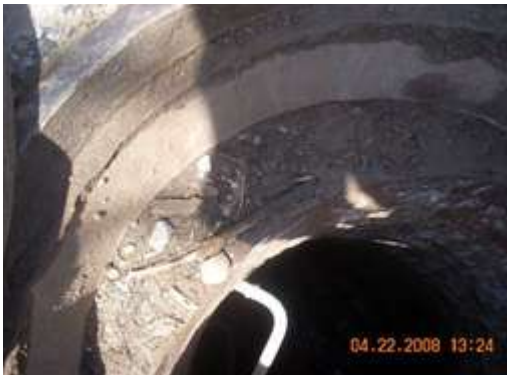
Defect 1

**Frame** Offset: **4** (in.) Condition: ☒ Sound ☐ Cracked ☐ Leaks

frame offset

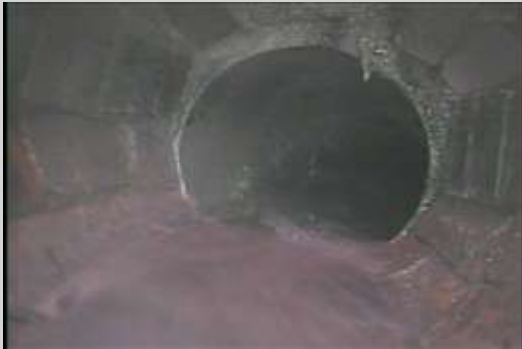
12 O'Clock Outflow

10 in. Circular Gravity Sewer  
Pipe Out @ 12 O'Clock

Pipe Height: **10.8** (in.) Rod and Bar (Angled)  
Pipe Material: **Clay** ☐ Pipe Lined  
Invert Depth: **12.49** (ft.) Flow Characteristics: **Slow**  
Deposits: ☒ None ☐ Mud ☐ Sludge ☐ Debris ☐ Grease  
Silt Depth: **0** (in.) Deposits Extent:  
Infiltration: **Evidence** Pipe Seal Cond: **Unknown**

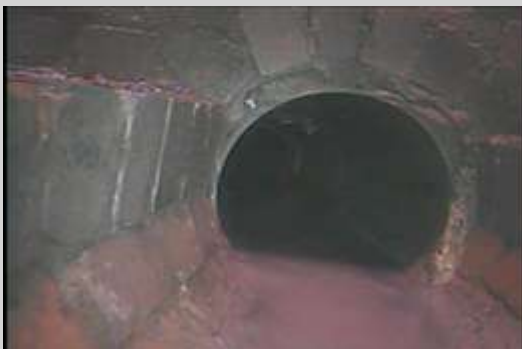
4 O'Clock Inflow

10 in. Circular Gravity Sewer  
Pipe In @ 4 O'Clock

Pipe Height: **9.6** (in.) Rod and Bar (Angled)  
Pipe Material: **Clay** ☐ Pipe Lined  
Invert Depth: **12.27** (ft.) Flow Characteristics: **Slow**  
Deposits: ☒ None ☐ Mud ☐ Sludge ☐ Debris ☐ Grease  
Silt Depth: **0** (in.) Deposits Extent:  
Infiltration: **None** Pipe Seal Cond: **Sound**
